# Application Profile

**Project:** Inside coating of a steel-silo (A).  
**Project supervisor:** Hoehnel GmbH, Linz (A)  
**Applicator(s):** Fastsetpowerunits, Landskron (A)  
Hoehnel GmbH, Linz (A)  
**System applied:** Gepotech 11/22, Xanten (D)  
**Substrate/Area:** sandblasted steel/1.200m<sup>2</sup>  
**Date:** 09. - 10.10.2008

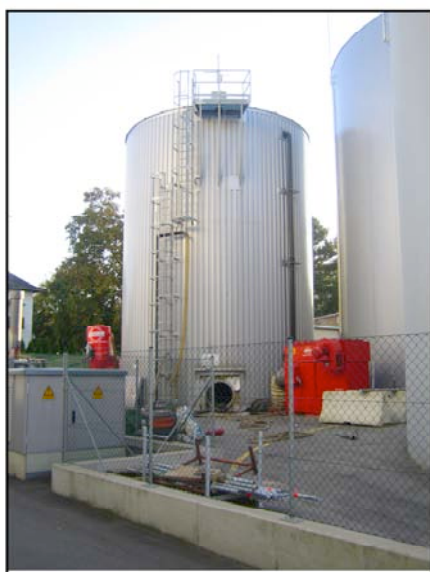
Steel silo

The company Hoehnel GmbH, which is a professional in steel-protection, have had the need, to apply the system Gepotech 11/22, a polyurethane-system, inside a steelsilo for corrosion protection and sealing.

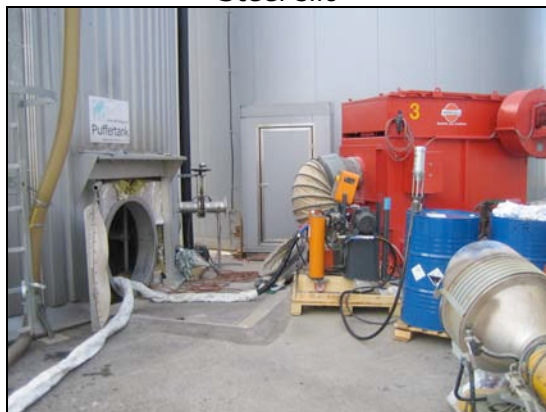
Placement of spray-machine

As for the expectancies of the application we choiced out a "GAMA Evolution G-250H" with 63m of material-hose and a "Master Gun" as spraygun (mixing chamber 01, roundspray).

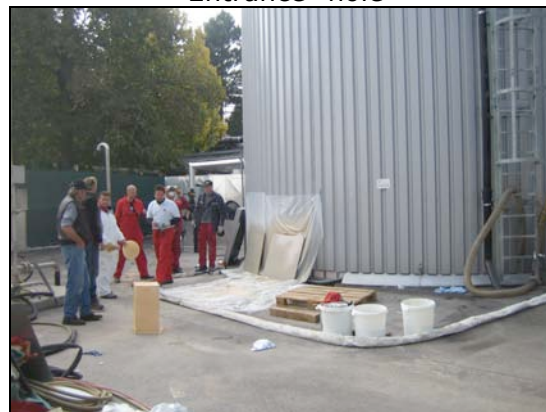
Test-spraying

The equipment was placed as usual and we sprayed out first tests. To all our wondrousness, the sprayed system did not react! It kept liquid and showed no reaction attributes.

So we checked out all the equipment to figure out the problem until we could see at least, that the manufacturer filled the drum of the "B"-side with MESAMOL-OIL!

After ex-changing the drum (and control the content before), the test-spray worked successful, the system reacted as expected and the labor-analyses attested perfect values.

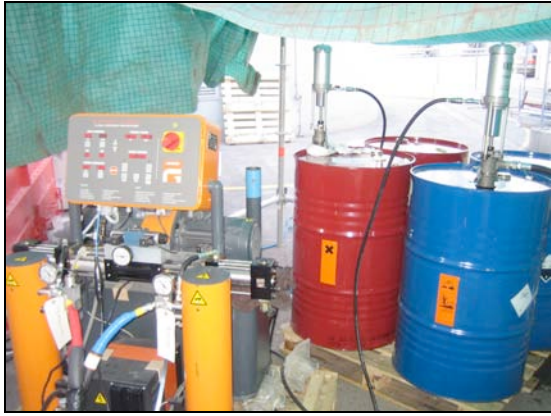
Working equipment

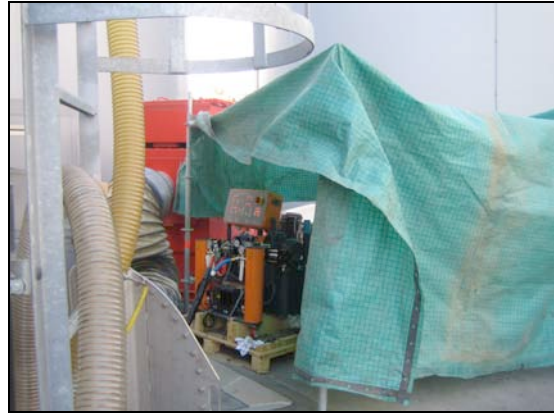
Covering and heating material

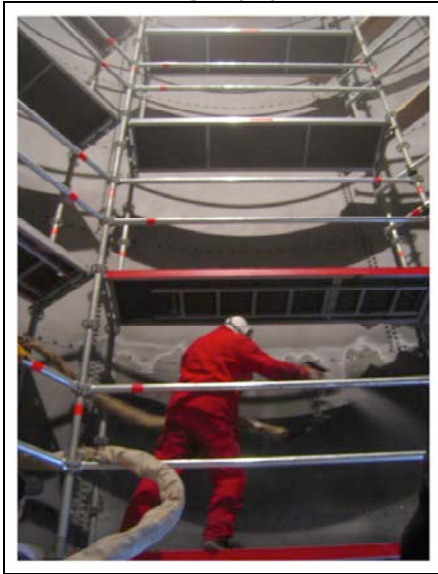
Spray-works

The spray-job was than done from 09. - 10.10.2008, while application all paramters were monitored and documentated by photos and videos.

Both application days were monitored and observed also through a local consultancy company, which made also thickness-tests, measurements of humidity and re-calculations of used material periodically. The spray-job itself was "easy-going", for some detail-works we have had to exchange to a smaller mixing-chamber (00, round), which could be done quick and without shutting off coating-equipment.

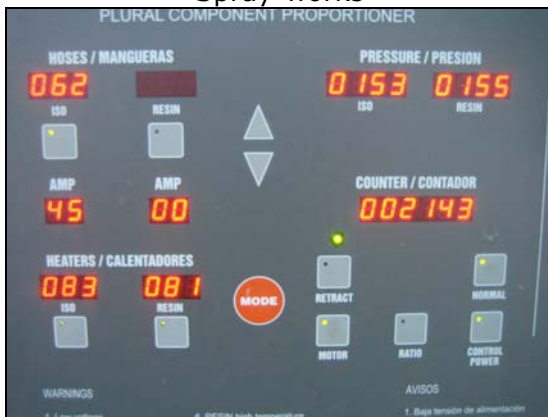
Application parameters

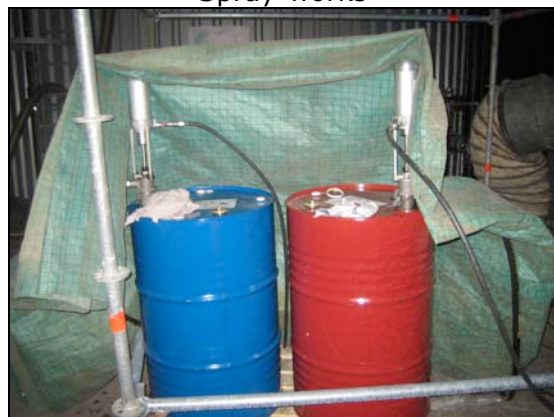
Gepotech system 11/22
